## Chapter 3. Results and Discussion --- Soil and Water Team

### 3-1 Hydrological Characteristics of the Dwinyan and Biem watershed

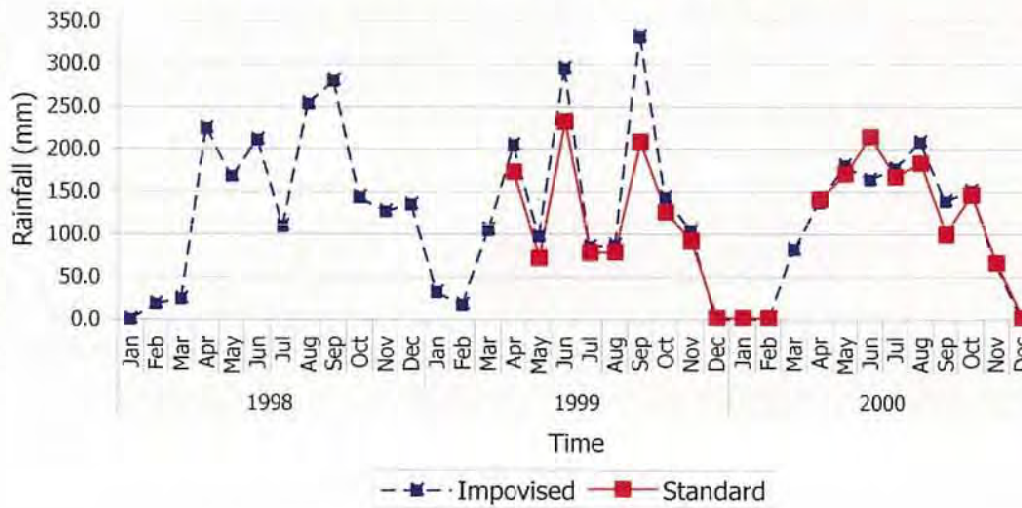
**Fig.3-2. Calibrating an improved raingauge - Asuodei**

In the case of the rainfall measurement at the two stations, improvised, as well as standard rain gauges were used. The improvised raingauge consist of a PVC pipe 40cm high with a diameter of 22cm, which is imbedded into the soil. A five litter plastic container (commonly used to carry water and other liquids) is placed inside the pipe in such a way that the neck of the container is at the level of the ground. A funnel of a known diameter is inserted into the neck of the container. The funnel receives the rain and directs it into the container. The cost is very low as compared with the standard raingauge and for the quality of data needed it quite adequate. An automatic rain gauge was also installed at Asuodei, which will help establish the rainfall intensity of the area. The values of the rainfall from the standard and improvised gauges are presented in Fig. 3-2 at Asuodei and Fig.3-3 at Potrikurom.

In the two figures, rainfall values from standard and improvised gauges are compared. The stations were located at the schools in the towns and the recordings are being done by the school children twice a day under the supervision of the teachers. The raw data as recorded at the meteorological stations. The mean monthly values of parameters at both stations are presented in Tables 3-1 & .3-2

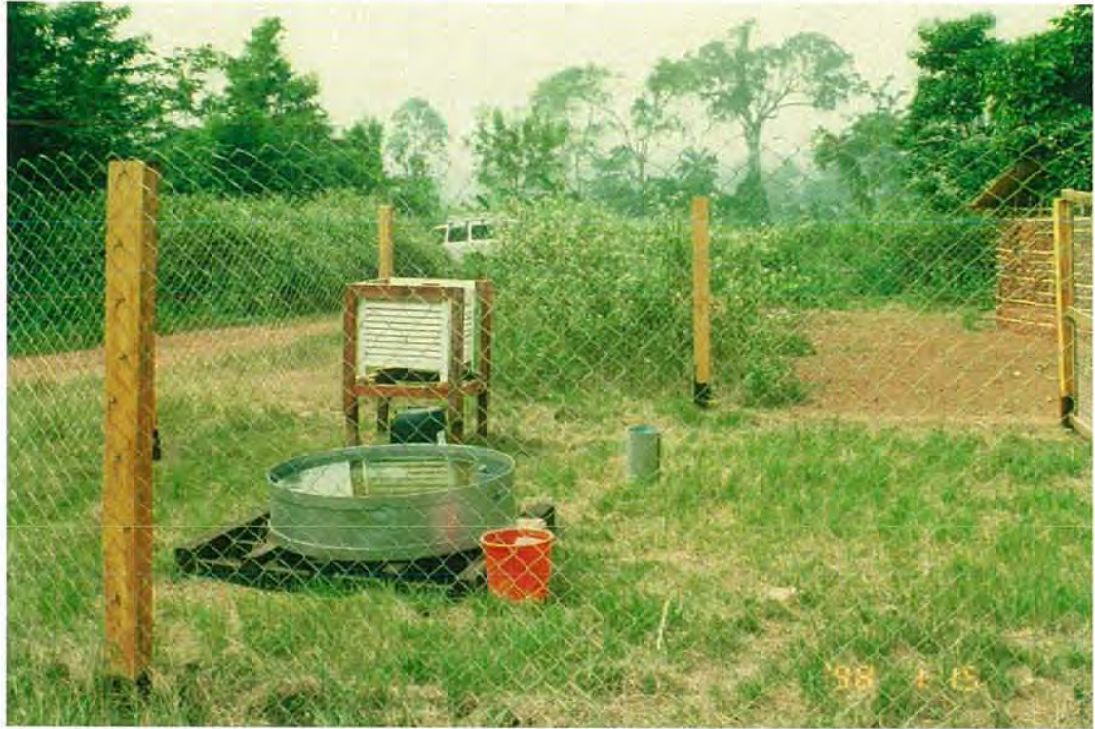
Photo. 3-1. Meteo Station

Two meteorological stations were established within the watershed; one upstream near the forest reserve at Asuodei and the other downstream at Potrikrom (Photo. 3-1). Parameters being monitored at these two stations are rainfall, temperature, relative humidity evaporation.(the pan A type). These parameters are to help in establishing the water balance of the Dwinyan Watershed which will in turn give an idea about the water resource of the watershed in terms of quantity and for that matter the area that can be successfully put under sawah.

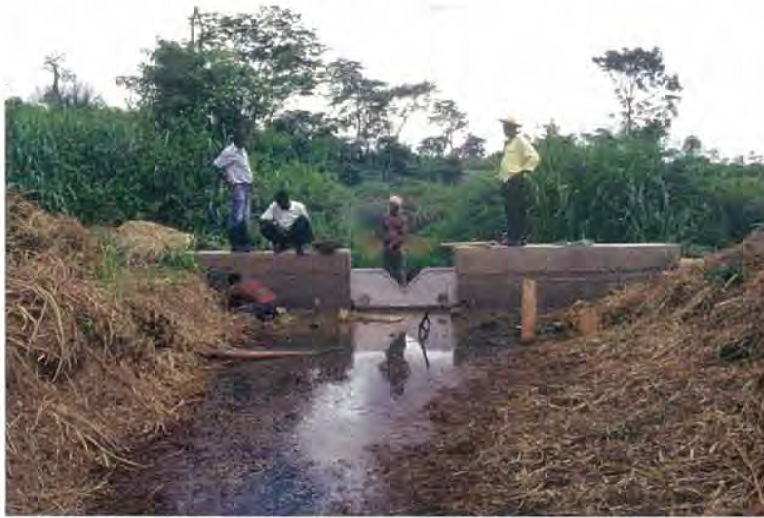
Photo. 3-2. Measuring of the flow by v-notch

$$Q = 13.8H^{2.5} \text{ (in litres/sec.)}$$

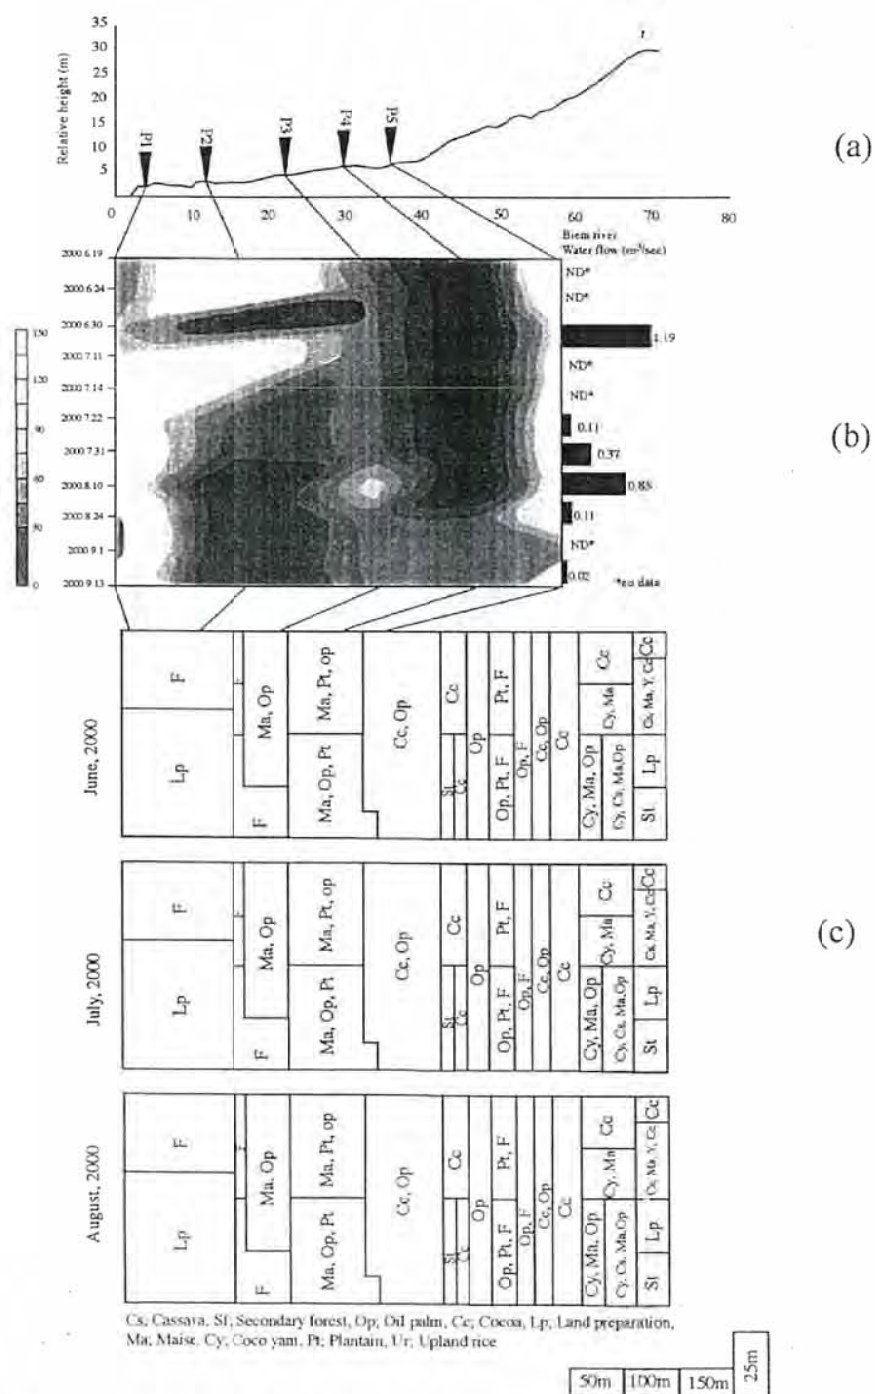
Fig. 3-15 (1). Change in water level land use along the transect line (Right side of T-11)

Along right stream of T-11, although two areas for cocoa and another large area of secondary forest dominated, the top of the hill was used for the cultivation of annual crops such as maize, cassava, cocoyam and plantain. Based on its topographical characteristic, it can be noted that the actual method of land cultivation is not suitable for the land shape.

Five transect lines in three different sites were set in benchmark Biem watershed and topographic information was collected (Figs.3-13, 3-14(1), 3-14(2), 3-15(1) and 3-15(2)). As observed in these figures, each transect has a different topography.

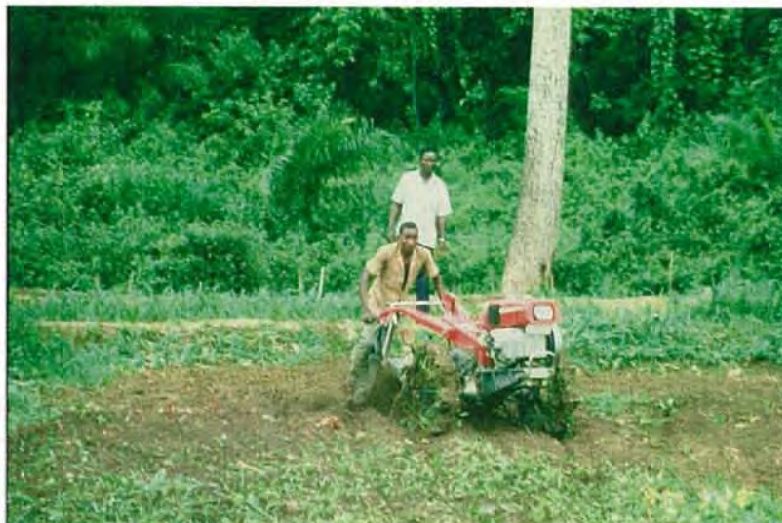
Photo. 3-9. Plowing and harrowing by the power tiller before leveling.

- v. **Plowing & Harrowing**  
Each plot is ploughed and harrowed using power tiller before final leveling (Photo. 3-9).
- vi. **Leveling**  
After irrigating the ploughed field, the field will be leveled. Moving soils from higher place to lower place according to the condition of flooding water, the surface of the field should be flat. Whether the field flat or not affects the necessary water volume to irrigate the whole area of the field. The flatter the field was leveled, the necessary water volume comes to be smaller. In this project, it was found that even by the man power, the height difference among one sawah bed could be 3cm. Also the size of the sawah bed affects the leveling result. The bigger the size bed need more serious attention to this procedure.(Photo. 3-10, 11 and 12)
